Bike and Pedestrian Safety Improvement Study

El Camino Real: Between Maple and Charter Streets

February 25, 2019

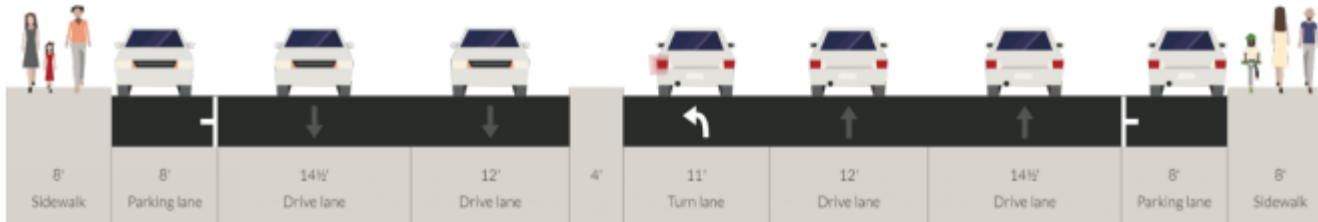
Existing

North Segment: Maple to Redwood (84 feet total, 4 travel lanes)

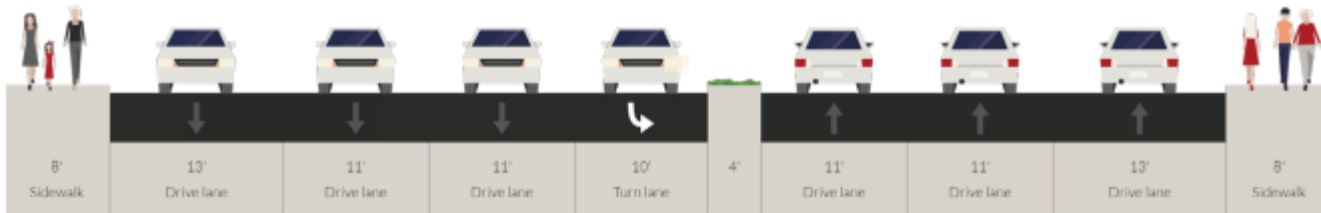
Existing

South Segment: Redwood to Charter (84 feet total, 6 travel lanes)

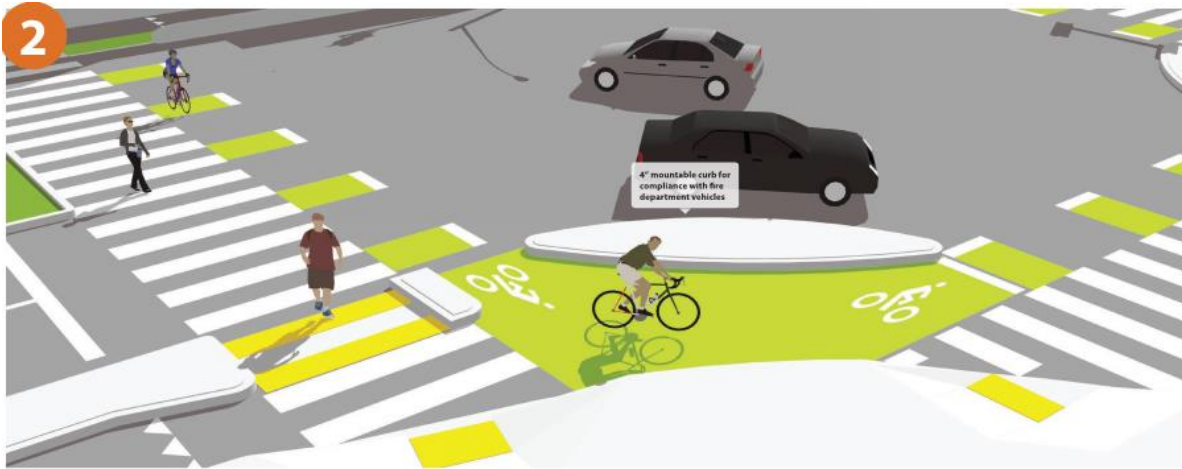
OPTION 2
Protected Corner/Intersection

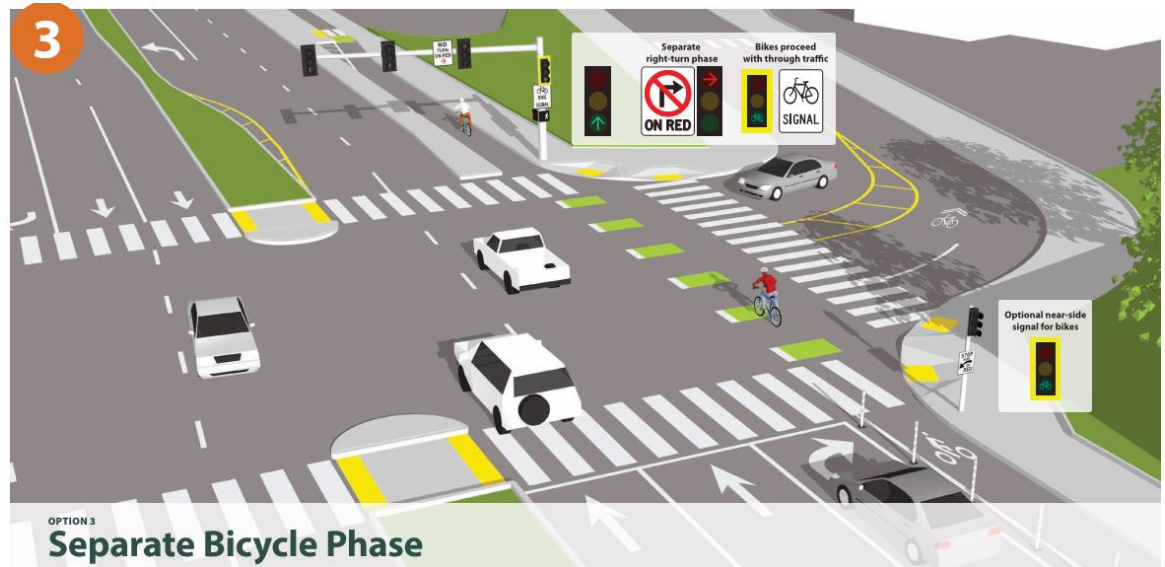
OPTION 3
Separate Bicycle Phase

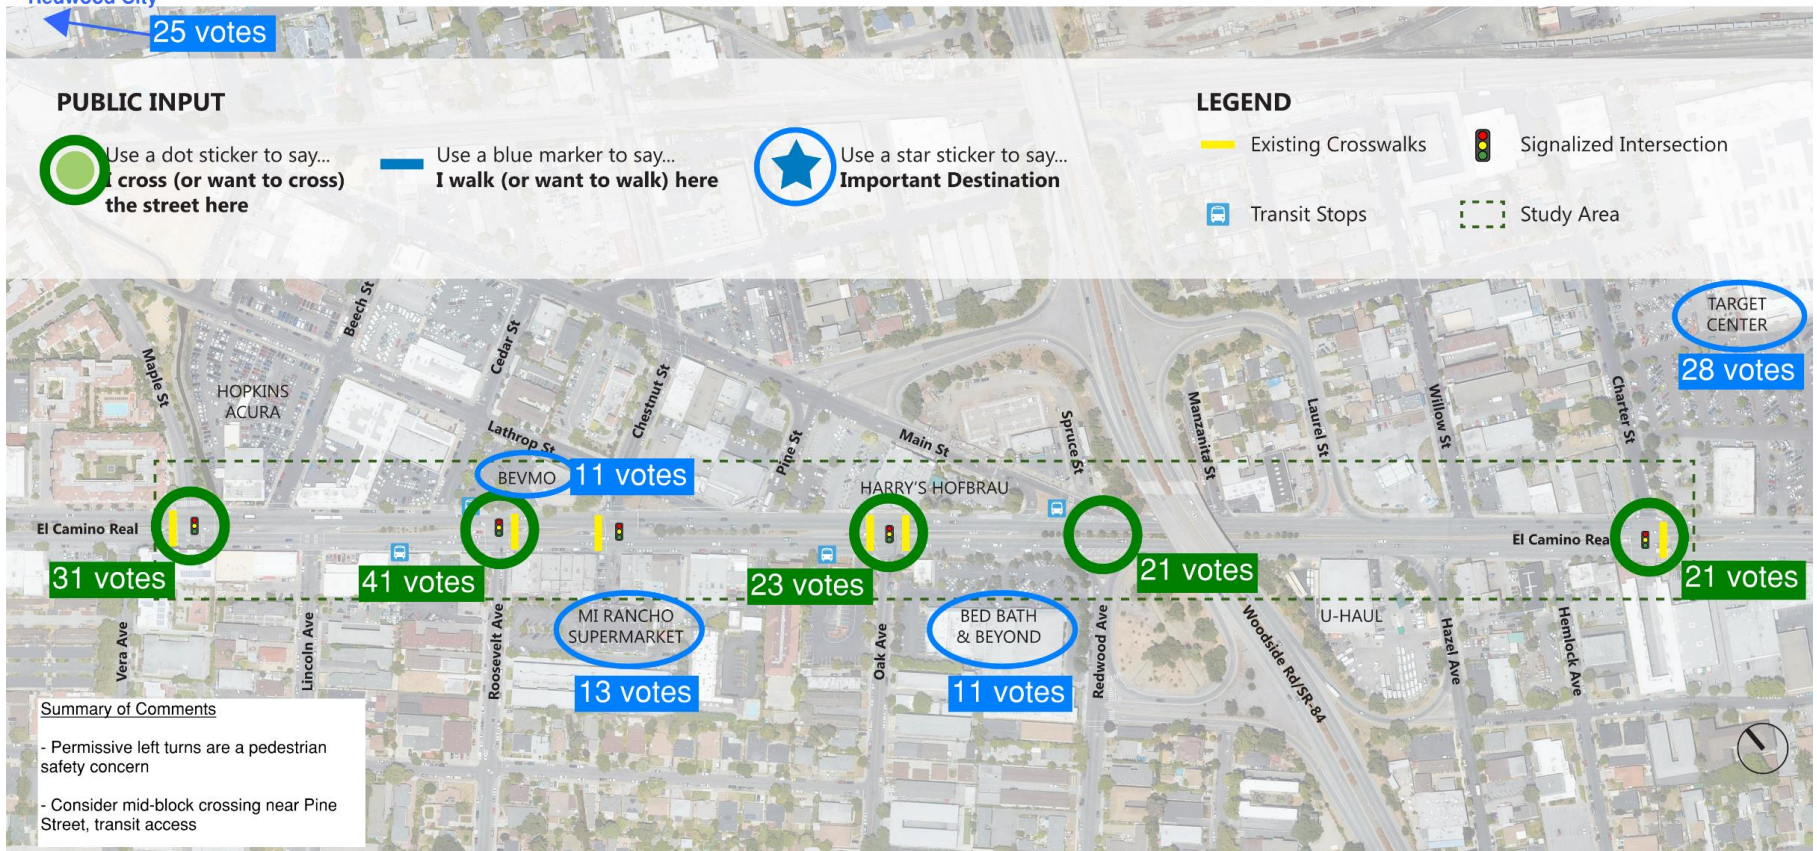
- Permissive left turns are a pedestrian safety concern
- Consider mid-block crossing near Pine Street, transit access

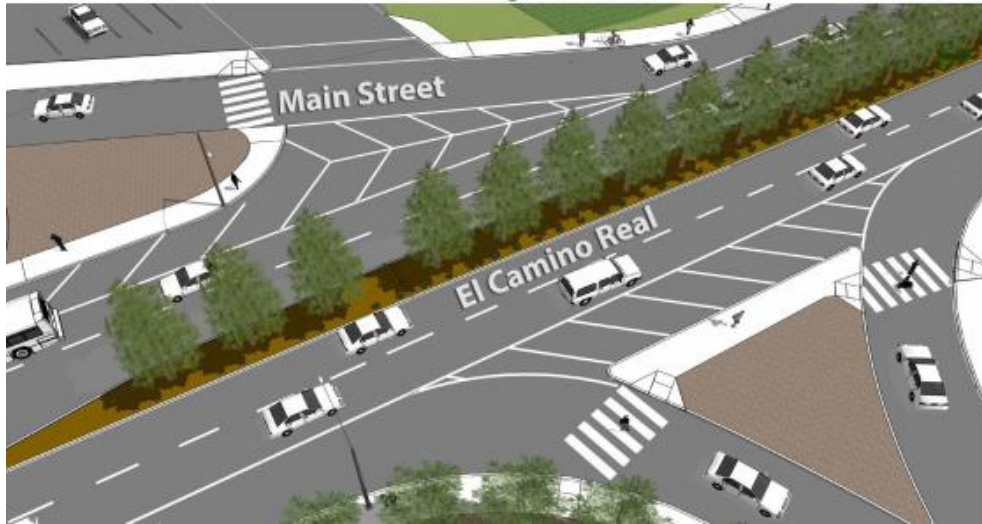
Existing

Street Alignments
